Organic Finishing Technologies

B-52 Paint Life Cycle Extension

Steve Finley, CTC
Support Contractor to
Mr. Tom Naguy
Air Force Research Laboratory

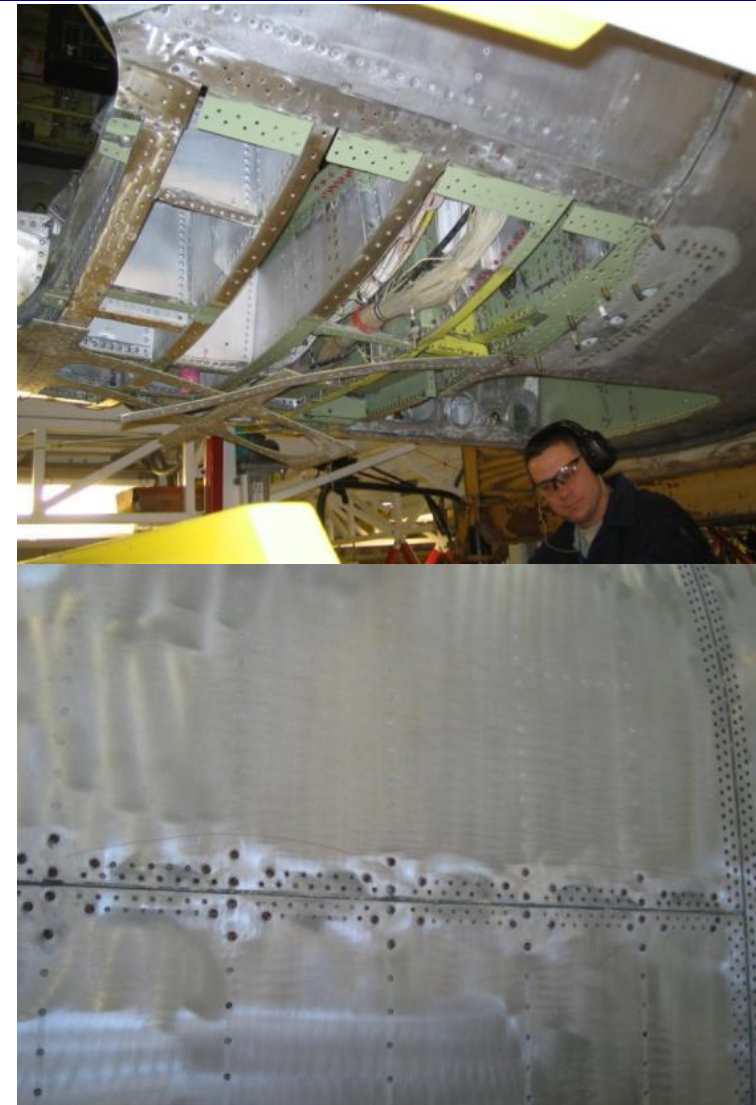
- **X-Ray Photoelectron Spectroscopy**
 - Cr+6 levels in samples were equal to samples taken from freshly applied primer
 - Indicates still enough Cr+6 to provide corrosion protection
- **Conclusions from Laboratory Testing**
 - Coating system next to substrate was nine years old; still had substantial Cr+6 levels
 - Variance in cross hatch and PATTI indicate it was time to paint the aircraft
 - Flexibility of the coating is still adequate
